MERRIMACK RIVER BASIN  
STERLING, MASSACHUSETTS

HYCREST FARM POND DAM  
MA 00673

PHASE I INSPECTION REPORT  
NATIONAL DAM INSPECTION PROGRAM

FEBRUARY 1979

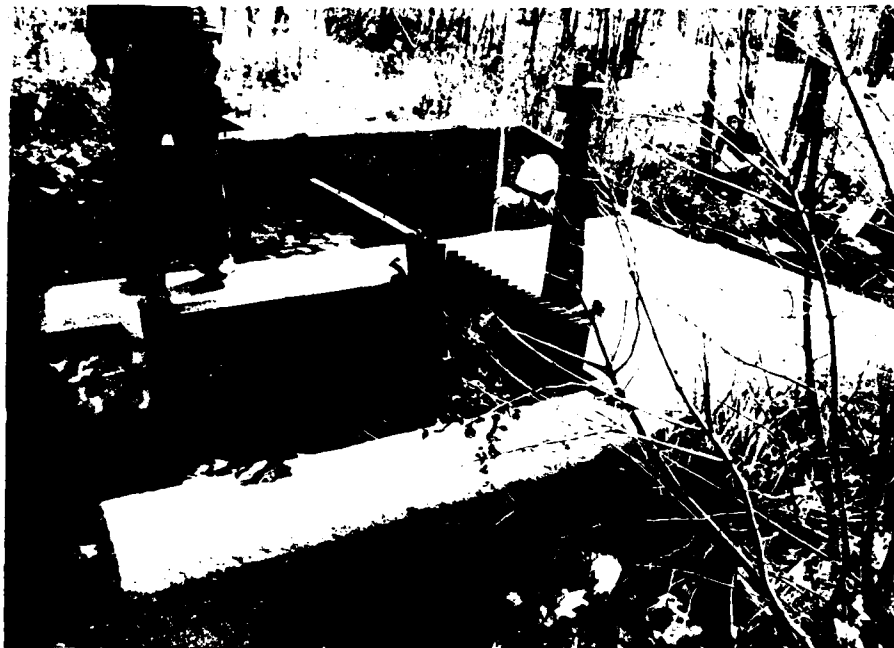
c. Appurtenant Structures. The spillway and incorporated pond drain structure, Photos No. 9 and 11, are in excellent condition. There is some minor erosion developing on the upstream sidewalls at the water line. The wooden flashboards, Photos No. 10 and 12, are in good condition. The stoplog slots at the pond drain intake, Photo No. 9, are in good condition but no stoplogs were observed. The gate operator handle for the pond drain was not in place. The handle is stored at the Owner's farm office. The operation of the drain was demonstrated on a subsequent site visit on 12 February 1979.

9. Upstream side of spillway and outlet structure
